**TAYLORS****PEST****SERVICES P/L**

## **Visual Timber Pest Inspection & Report in Accordance with AS 4349.3-2010**

**Undisclosed Eleebana NSW 2282**

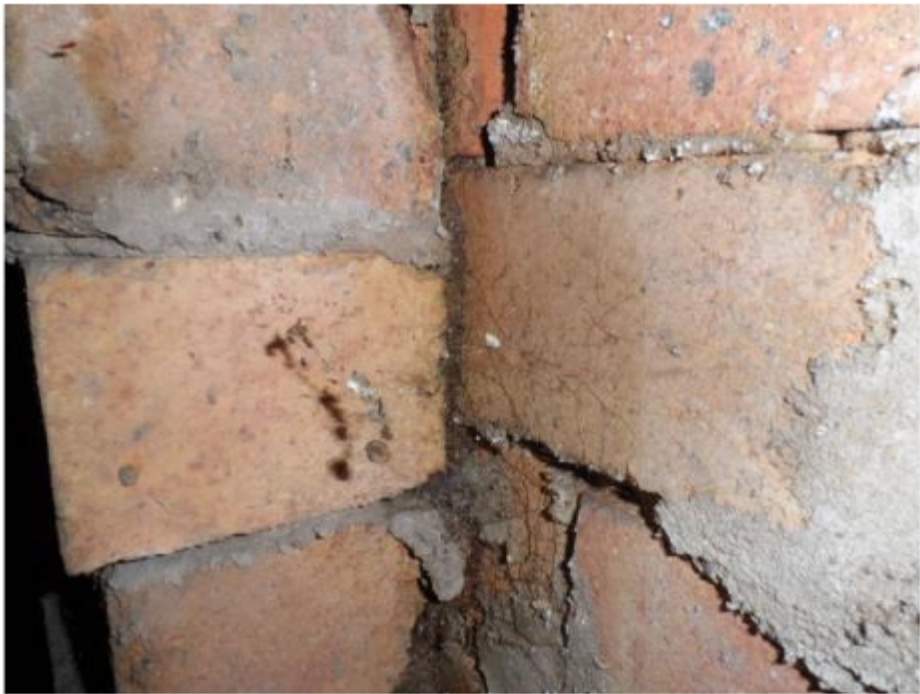
| Subfloor(1) | |
|---|--|
| Location of Threats<br>Not Limited To | Joists:Termite<br>Comment: Termite damage in joist & bearers timbers in subfloor, termite workings up engaged pier of subfloor, timber bearer in contact with soils in subfloor |

Subfloor(1) - Termite working up engaged pier in southern foundation in  
subfloor Image 1 of 5

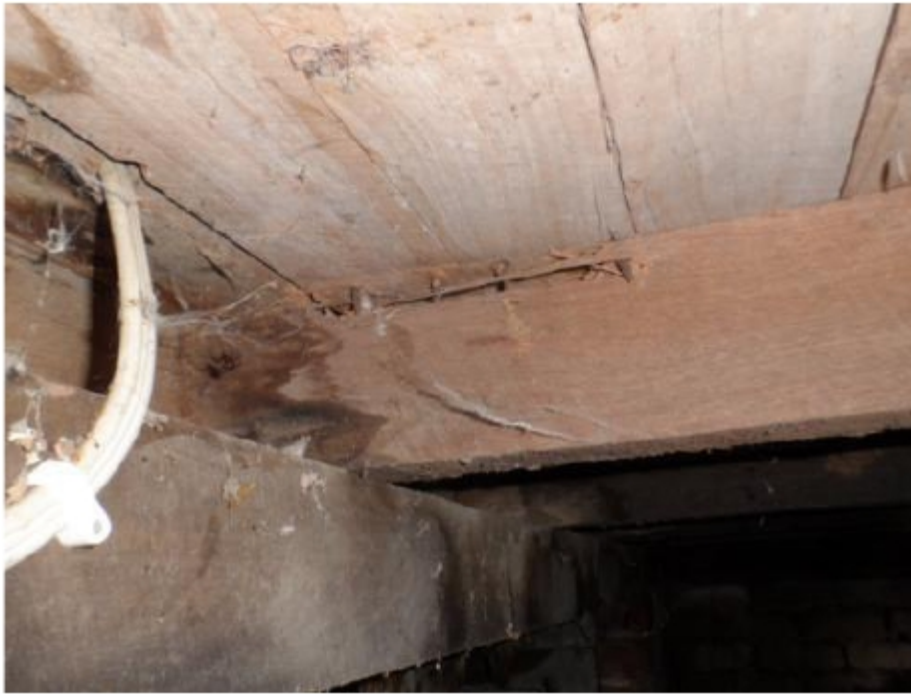
Subfloor(1) - Termite damage to timber joist in subfloor Image 2 of 5

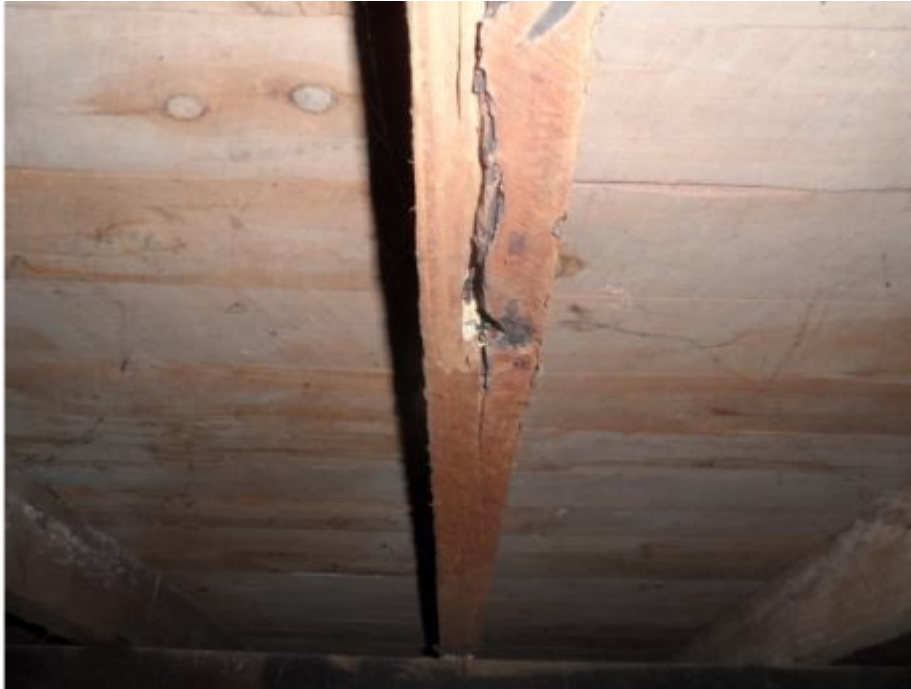
Subfloor(1) - Termite damage to timber joist of subfloor Image 3 of 5

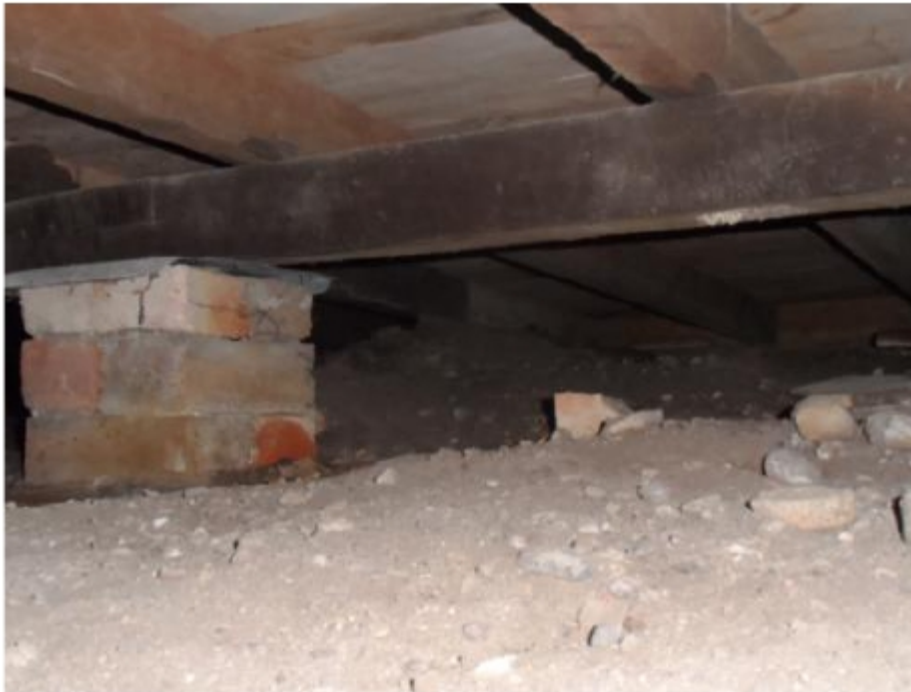
Subfloor(1) - Timber joist in ground contact of subfloor, build up of soils against joist timber Image 4 of 5

| CONDITIONS PRESENT | |
|---|--|
| Subfloor Conditions | Moisture<br>Comment: Soil built up against timber joist in subfloor, timber structure in ground contact on north eastern corner of structure, in adequate ventilation to subfloor, damp soils along foundation walls in subfloor |

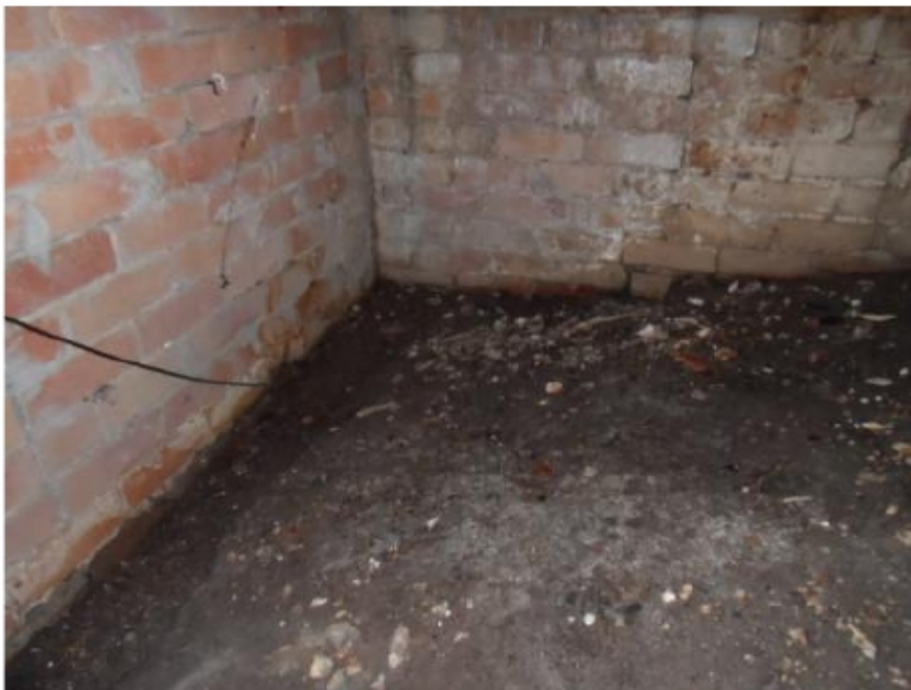
| Subfloor(1) | |
|---|--|
| Moisture | High<br>WARNING:SEE NOTE ON HIGH MOISTURE<br>Comment: High moisture reading detected in subfloor |

Subfloor(1) - Damp soils along foundations in subfloor area Image 5 of 5

Recommend drainage improvements along rear (eastern side) of structure to reduce moisture in subfloor,  
Recommend ventilation improvements along front foundation of structure

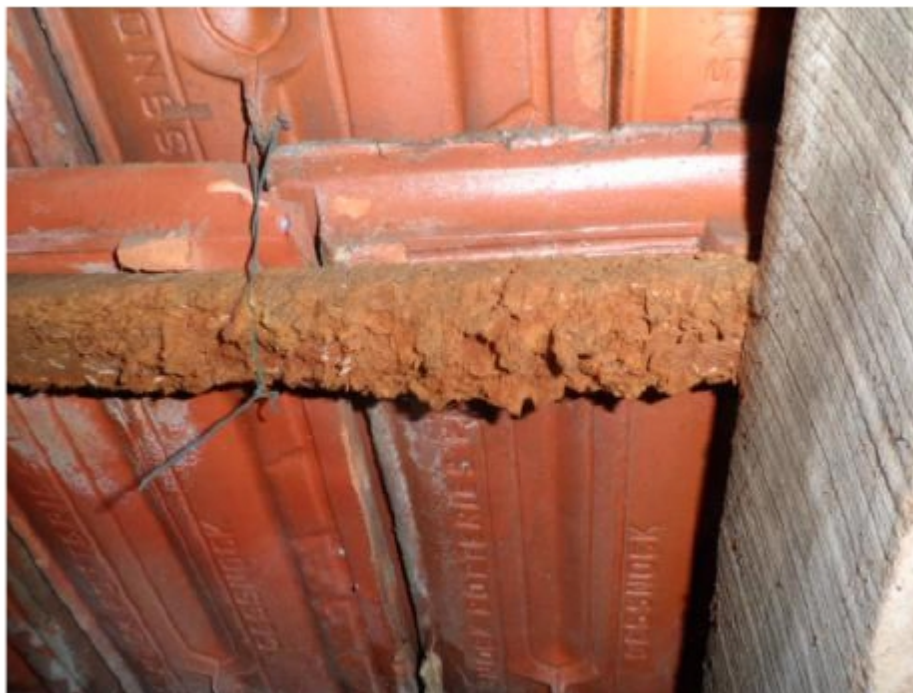
Roof Void(1) - Delignification to timber batten in roof void Image 1 of 1

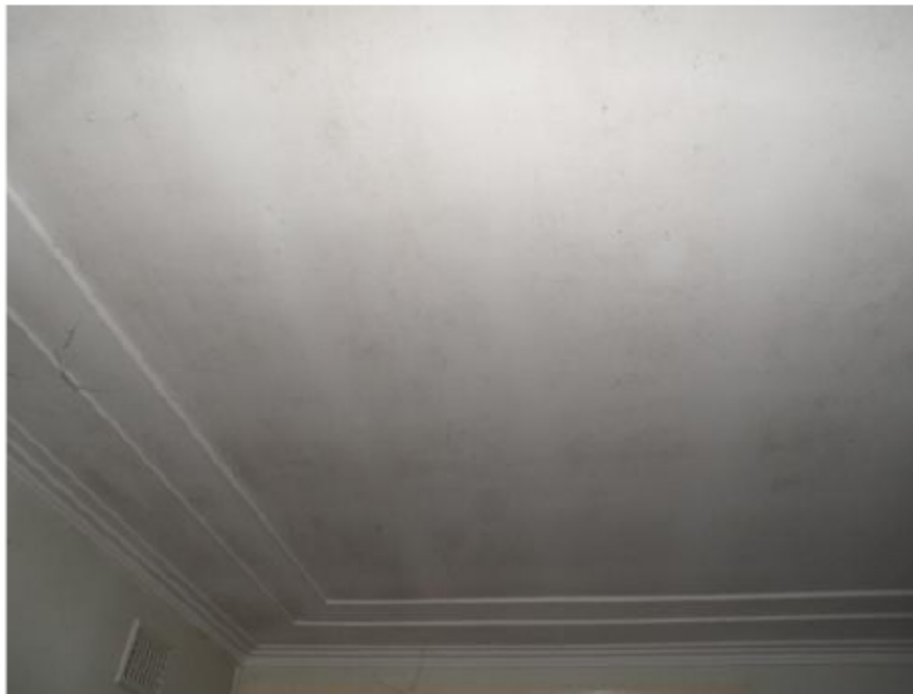
Bedroom(1) - Mould on internal ceiling of front bedroom Image 1 of 1

**MOULD:** Mould on walls and ceilings etc; is an indicator of high moisture or very poor ventilation. If reported You need to have the reason investigated by a builder or a Industry Hygienist as its presence may indicate the presence of a water leak, wood decay or termites behind the wall or ceiling sheeting.

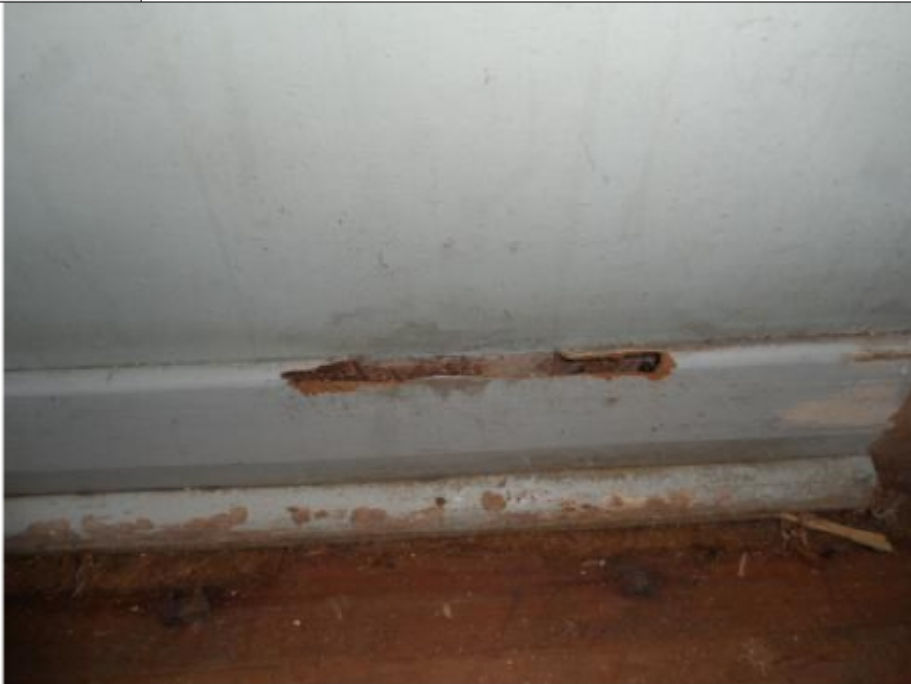
| Bedroom(2) | |
|---|--|
| <b>Location of Threats<br/>Not Limited To</b> | Skirting Boards: Termite<br>Furniture or Fixtures (eg Cupboards): Termite<br>Comment: Termite damage in lower skirting board & cupboard of bedroom 2 |

Bedroom(2) - Termite damage to skirting board timber in bedroom 2 Image 1 of

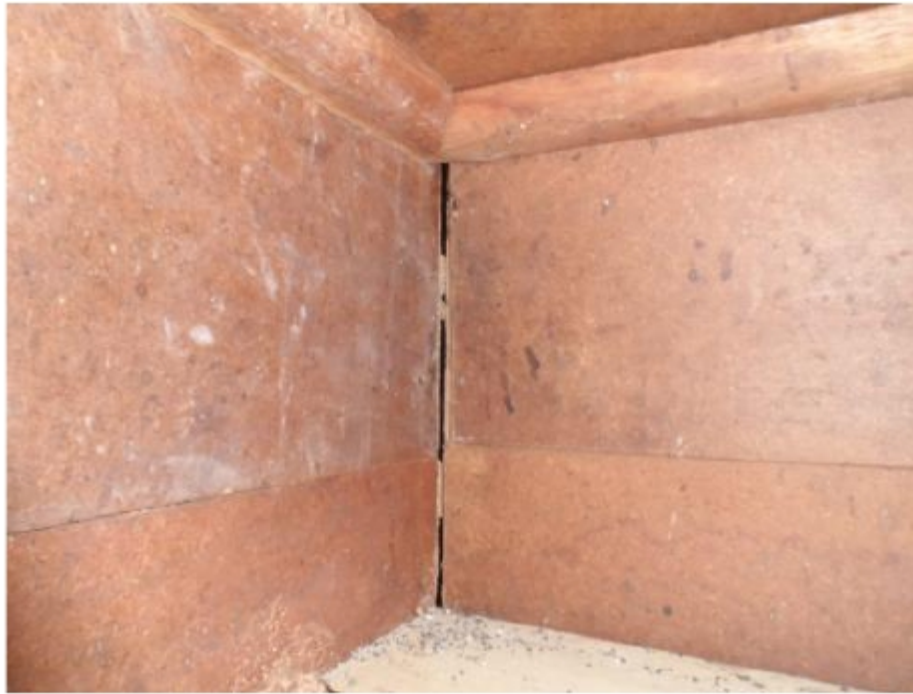
Bedroom(2) - Termite working in cupboard of bedroom 2 Image 2 of 2

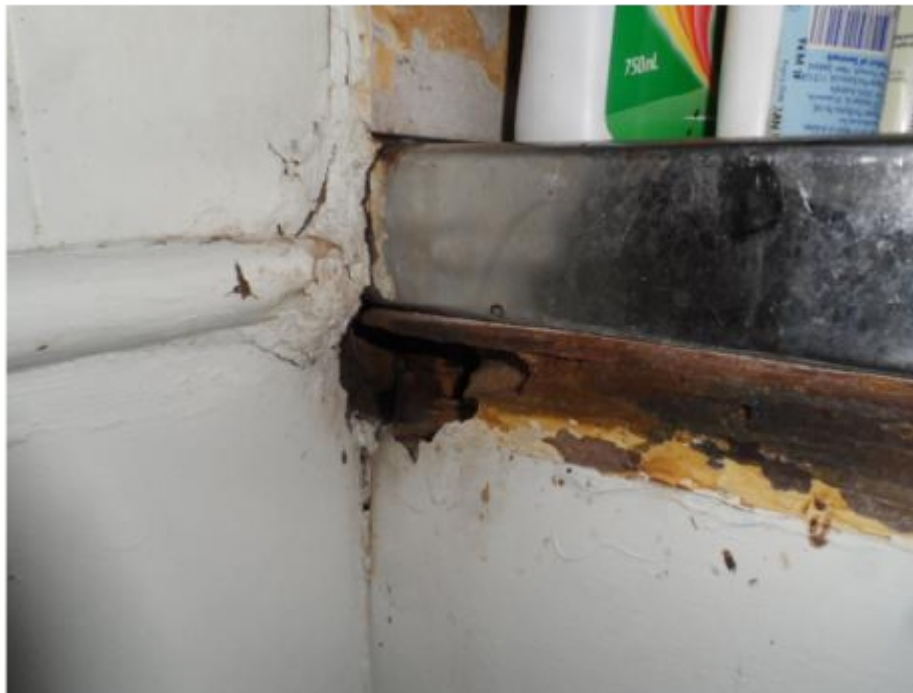
| Kitchen(1) | |
|---|--|
| <b>Location of Threats<br/>Not Limited To</b> | Furniture or Fixtures (eg Cupboards): Termite<br>Comment: Termite damage in kitchen cupboard |

Kitchen(1) - Termite damage in kitchen cupboard Image 1 of 3

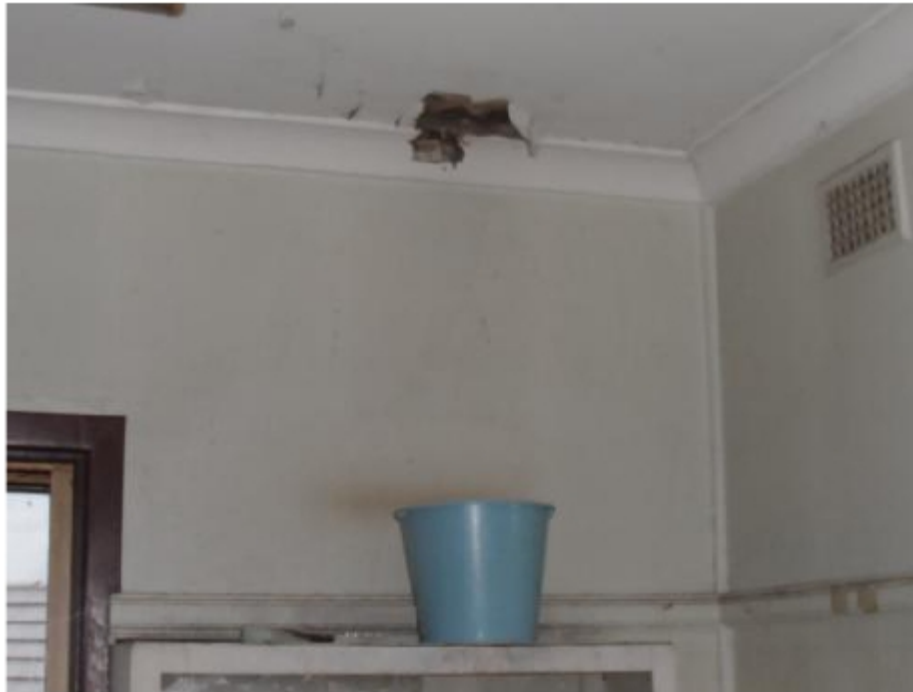
| Kitchen(1) | |
|---|--|
| <b>Moisture</b> | High<br>WARNING: SEE NOTE ON HIGH MOISTURE<br>Comment: High moisture readings were detected in kitchen wall & ceiling |

Kitchen(1) - High moisture readings detected in internal wall & ceiling of kitchen Image 2 of 3

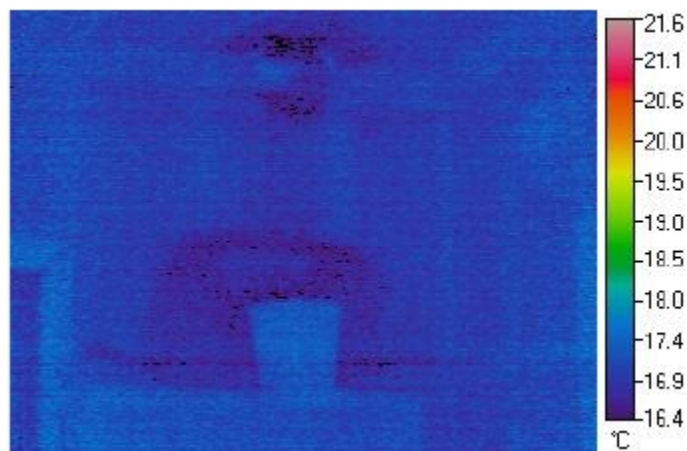
Kitchen(1) - Thermal tracer detected moisture on internal wall & ceiling of kitchen Image 3 of 3

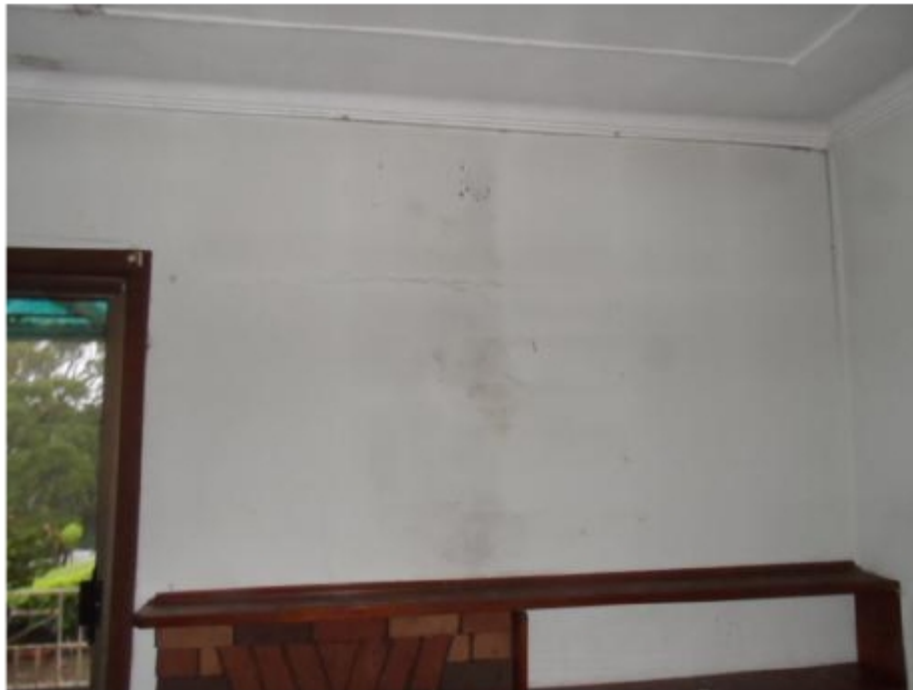
| LoungeRoom(1) | |
|---|---|
| <b>Moisture</b> | High<br>WARNING: SEE NOTE ON HIGH MOISTURE<br>Comment: High moisture readings detected in lounge room wall above fireplace |

Lounge Room(1) - High moisture readings were detected in wall of lounge room Image 1 of 2

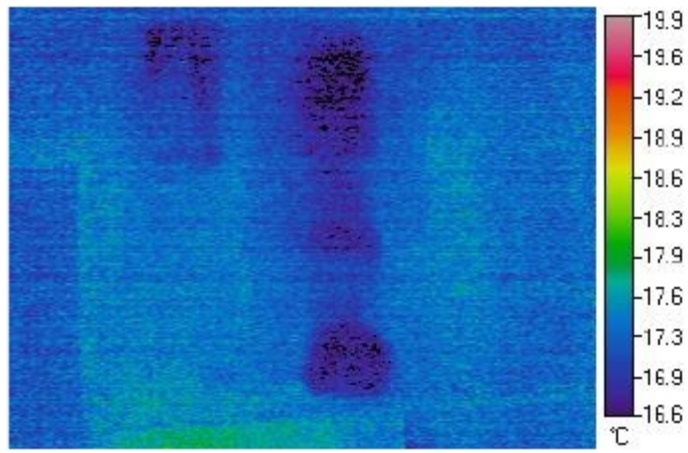
Lounge Room(1) - Thermal tracer detected moisture in wall of lounge room  
Image 2 of 2

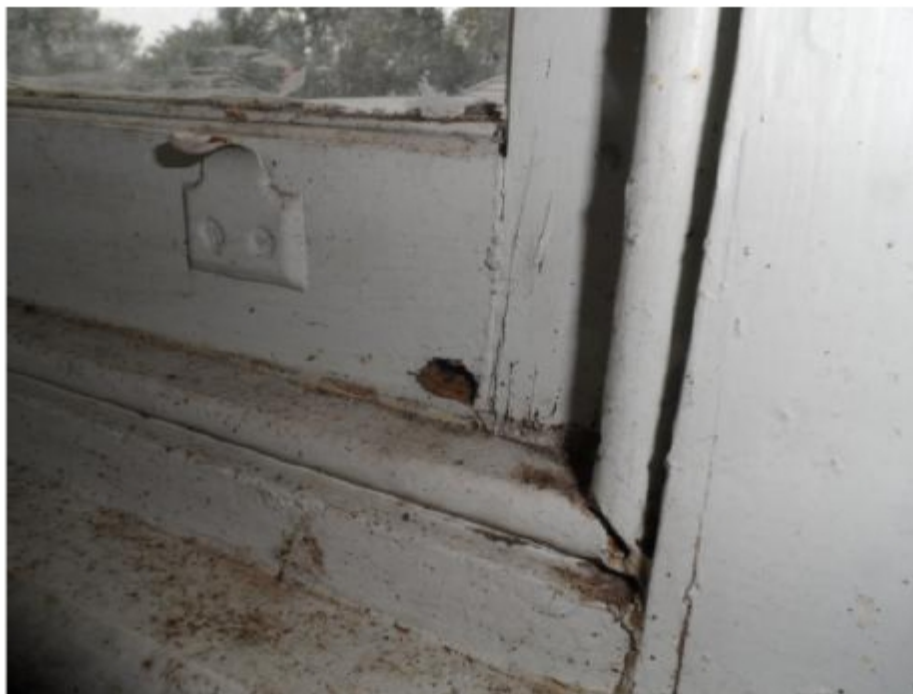
| Laundry(1) | |
|---|---|
| <b>Location of Threats Not Limited To</b> | Door Frames: Termite<br>Window Frames: Termite<br>Comment: Termite damage/workings in window & door framing timbers of laundry |

Laundry(1) - Termite damage in window framing timber of laundry Image 1 of

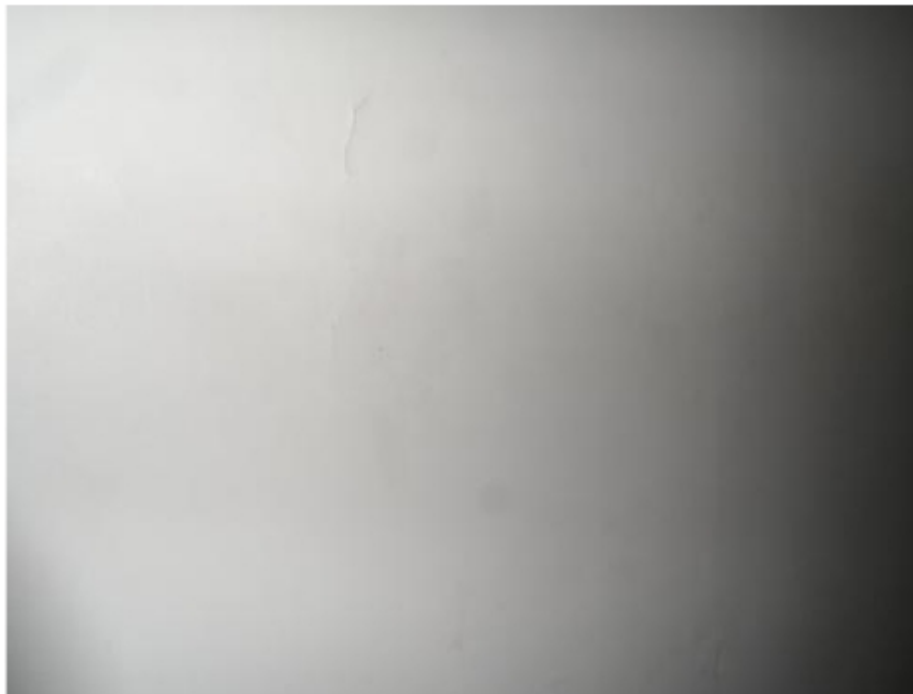
Hallway(1) - Uneven surface to internal wall in hallway Image 1 of 1

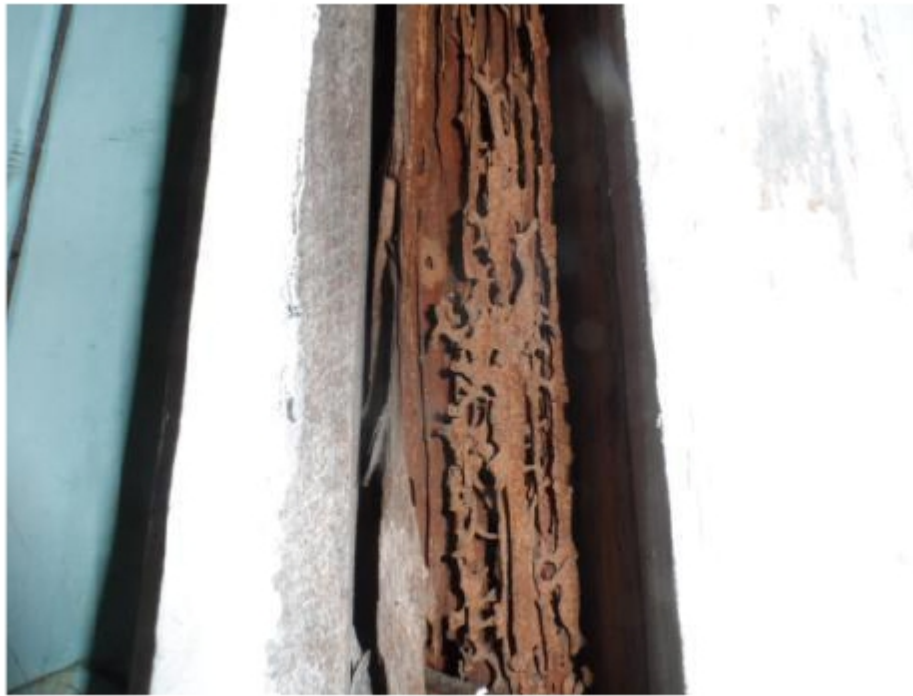
| External Structure-General | |
|---|---|
| <b>Location of Threats<br/>Not Limited To</b> | Walls: Fungal Decay<br>Door Frames: Termite<br>Rear patio timbers: Fungal Decay<br>Comment: Termite damage in external laundry door framing timber, fungal decay in external weatherboard timbers |

External Structure - General - Termite damage to external laundry door framing timbers Image 1 of 6

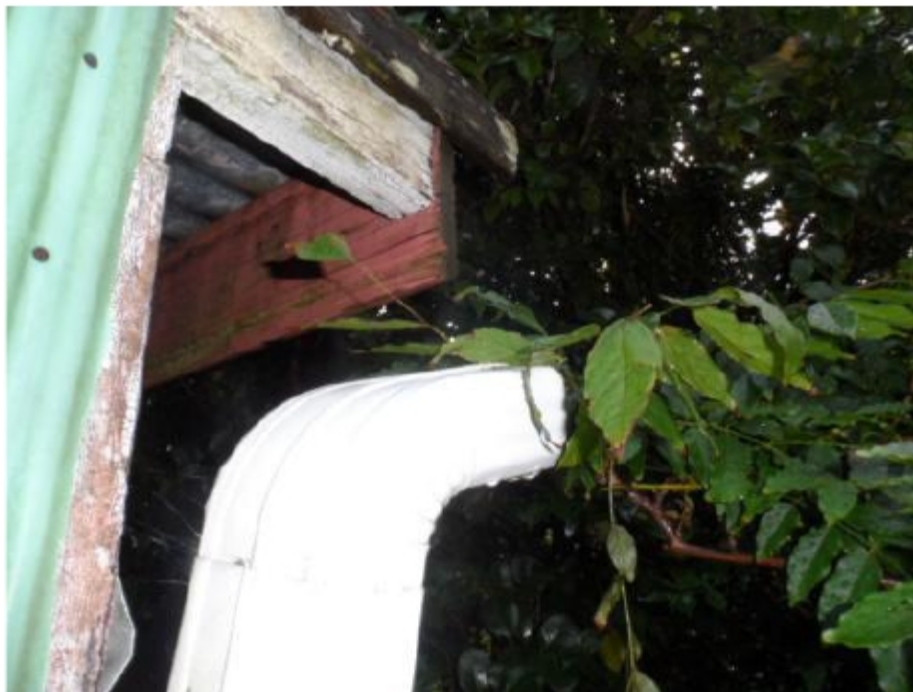
External Structure - General - External down pipe at side of patio not connected or properly drained away Image 2 of 6

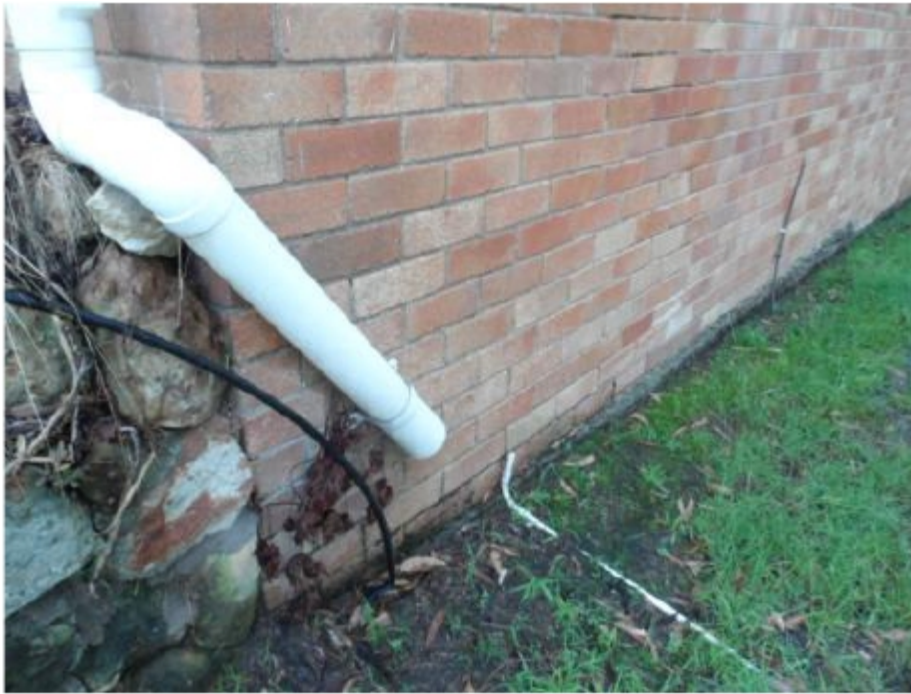
External Structure - General - External down pipe at front of structure not connected or properly drained away Image 3 of 6

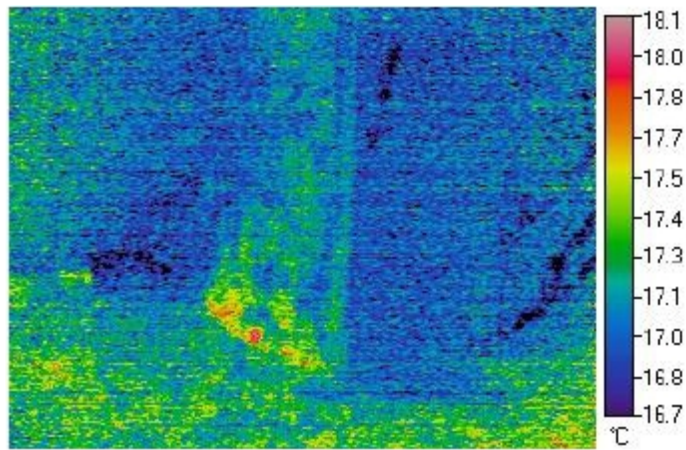
External Structure - General - Thermal anomaly in base of tree in rear yard  
Image 5 of 6

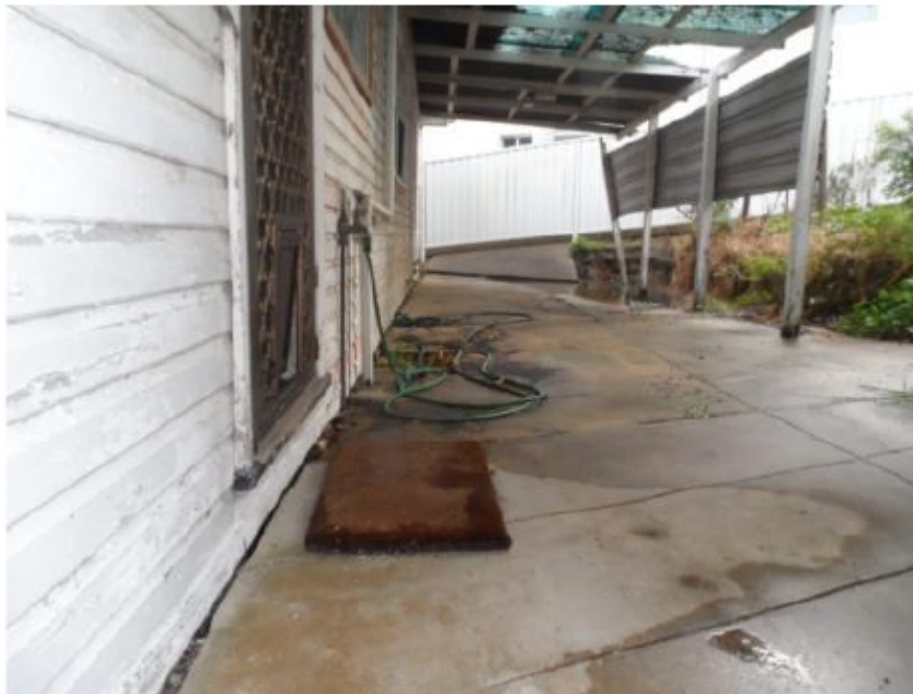
External Structure - General - Recommend drainage improvements along  
eastern side of structure Image 6 of 6

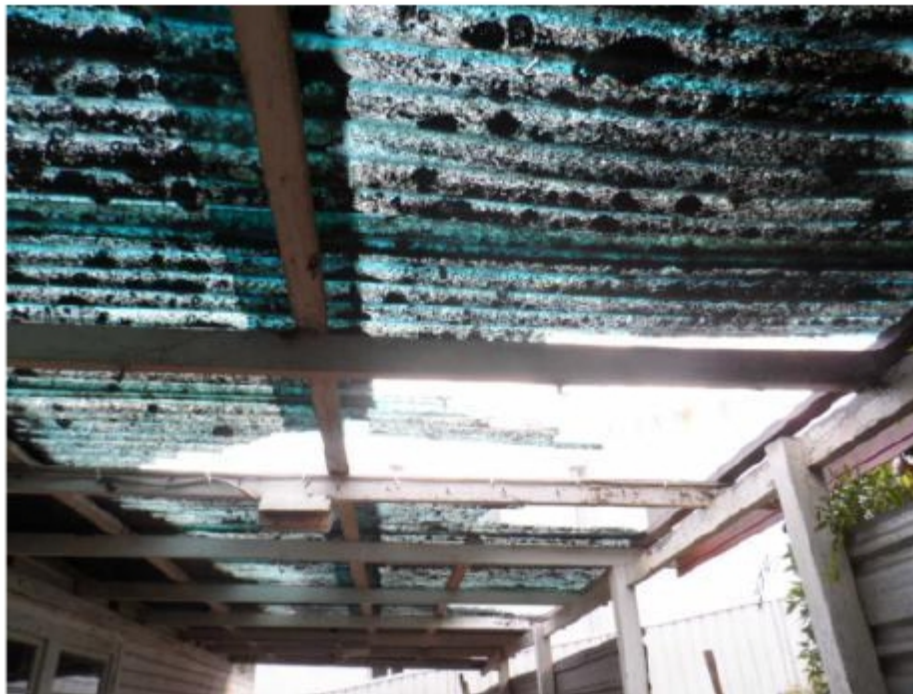
| <b>Exposed Timbers</b> | Exposed Timbers Present<br>SEE NOTE ON TIMBERS EXPOSED TO WEATHER AND/OR WATER<br>Non-durable Timbers: Timber in ground or ground contact<br>Location: Rear patio<br>Recommendation: Maintain exposed structure timbers on rear patio |

Site Improvements - Attached patio at rear of structure Image 1 of 1

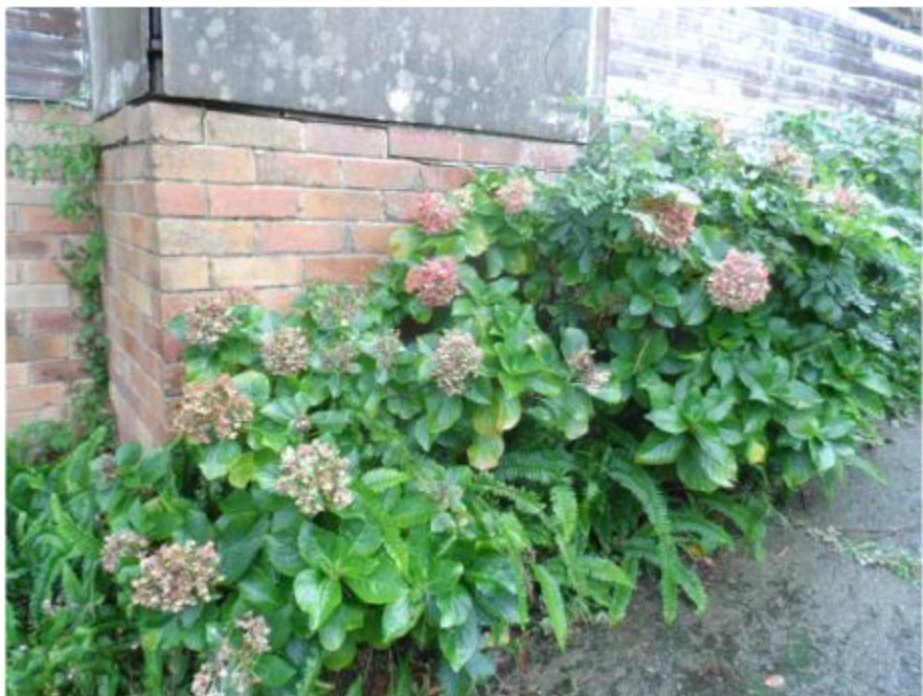
| CONDITIONS PRESENT | |
|---|--|
| Vegetation Against Structures | Garden Structure, Main Building, Fence<br>Comment: Vegetation against external (southern side) structure |

Vegetation against structures - Foliage against external structure Image 1 of 6

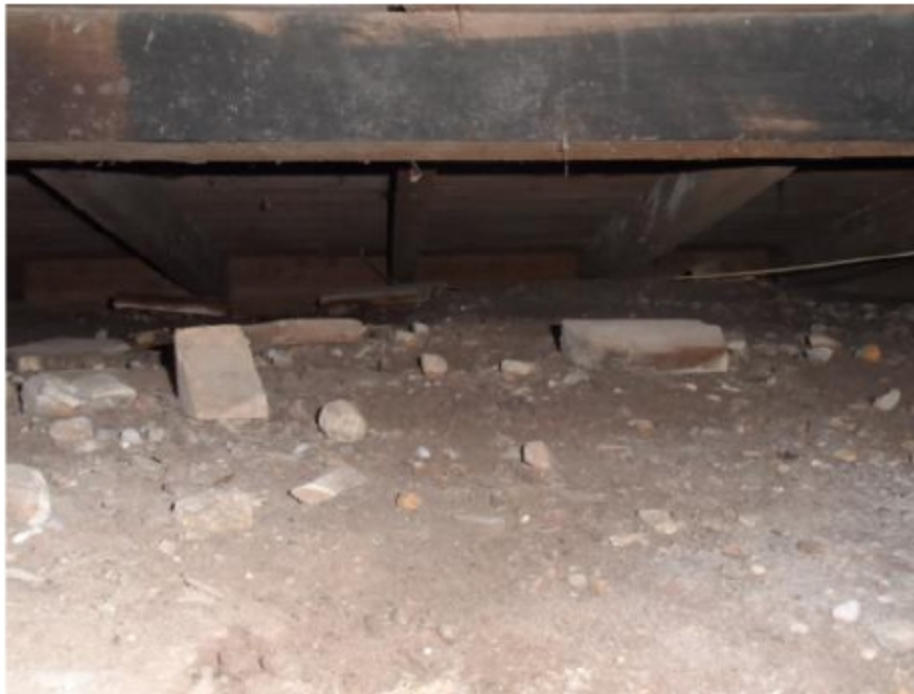
Subfloor - Timber structure at rear section of subfloor in ground contact  
Image 2 of 6

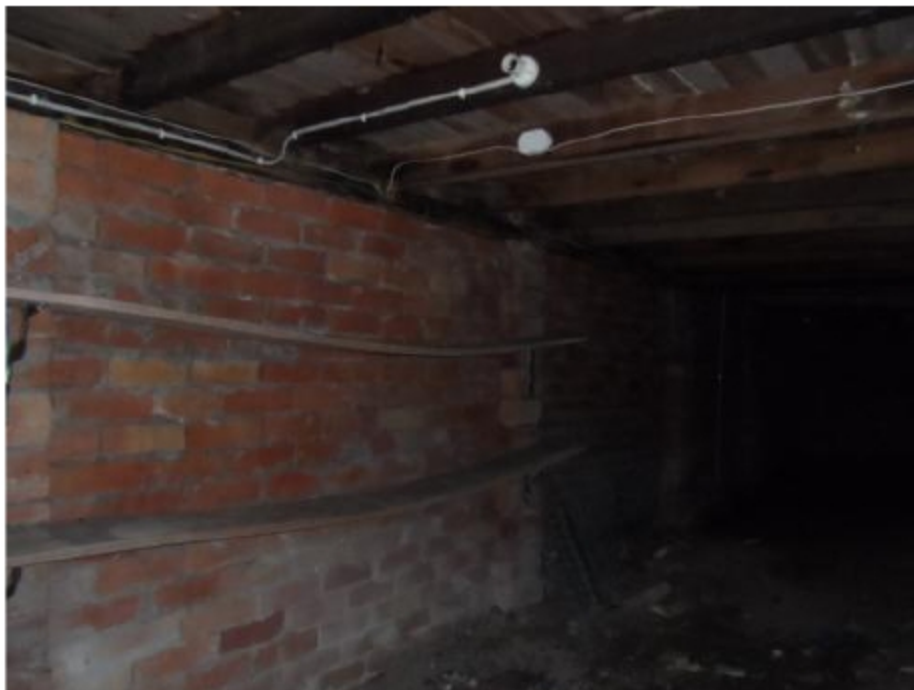
Subfloor - Inadequate or no ventilation in brick foundation of subfloor Image 3  
of 6

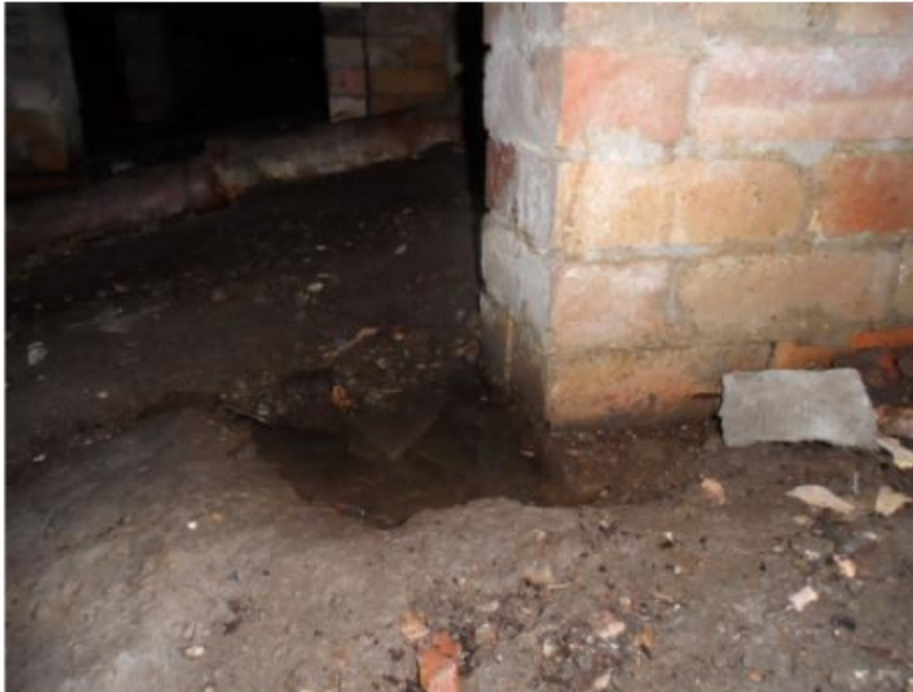
Subfloor - Water pooling around piers in subfloor Image 4 of 6

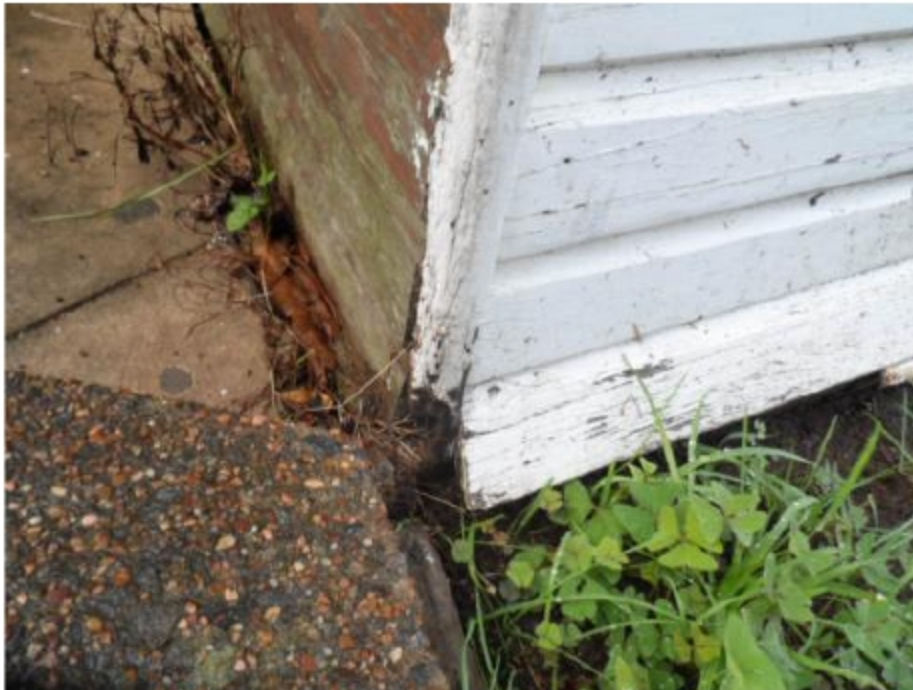
Exterior - External wall structure (northeast corner) in direct ground contact  
Image 5 of 6

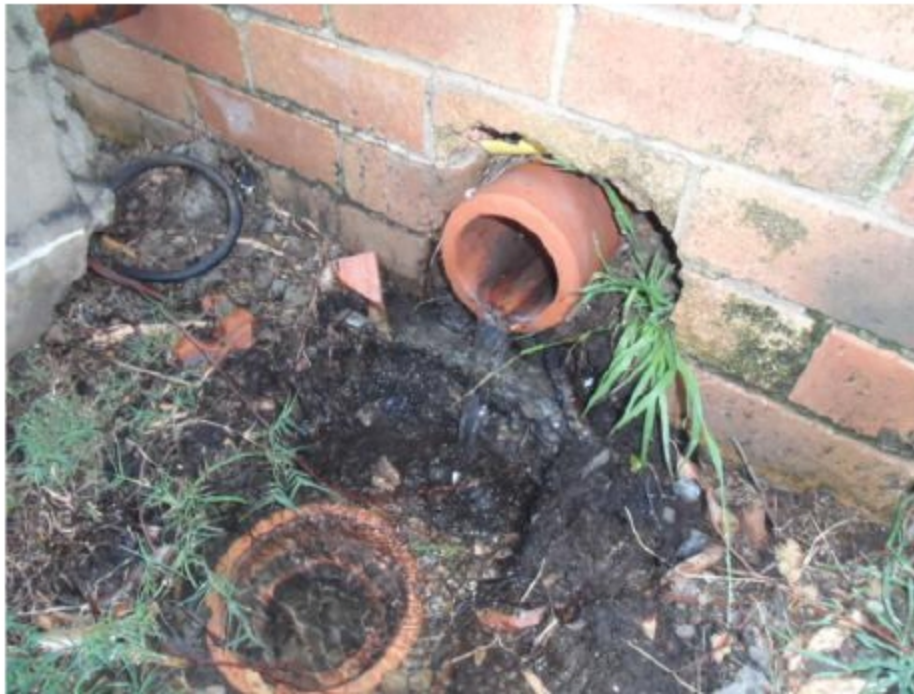
| CONDITIONS PRESENT | |
|---|--|
| Exterior Conditions | Water Leaks, Moisture, Tree Stump, Tree, Air conditioning/Hotwater Systems<br>Comment: Down pipes not connected or drained away properly, sewer pipe at front of structure not connected |

Exterior - Open sewer pipe-not connected Image 6 of 6
